Effect of drawdown of Karli Lake: A Case Study of Karli landslide hazard in District Hattian, Northeast Himalayas of Pakistan

Muhammad Basharat¹, Joachim Rohn², Muhammad Rustam Khan¹

¹Institute of Geology, University of Azad Jammu and Kashmir, Pakistan

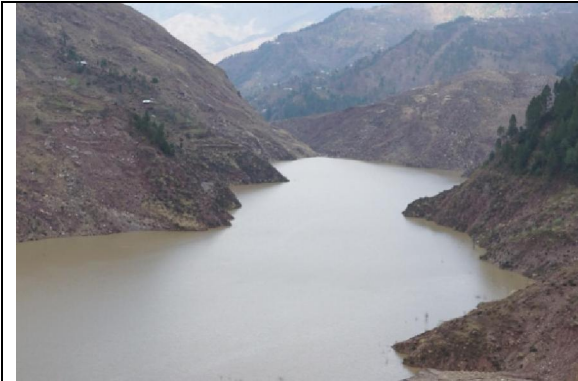
upper part of the slope and damaged the Sudhan Gali – Bagh road (Figure 2). The 2005 Kashmir earthquake triggered the Hattia Bala landslide that blocked the Karli and Tung river and formed landslide dams. In February 2010, following the 5 days heavy rain fall, Karli dam breached out that resulted activation of Karli landslide. According to the local eyewitnesses the landslide movement initiated after falling down of

water level of the Karli lake (Figure 5). The movement of the area continued for about a week. The affected area measuring about 1 km long and 800 m wide (Figures 6) damaged about 156 houses and displaced 900 inhabitants. At present the total area of Karli landslide is 195 acers and 45 acers area poses a potential threat of landslide in future.

Figure 5. In February 2010, Karli lake breach out that resulted activation of landslide

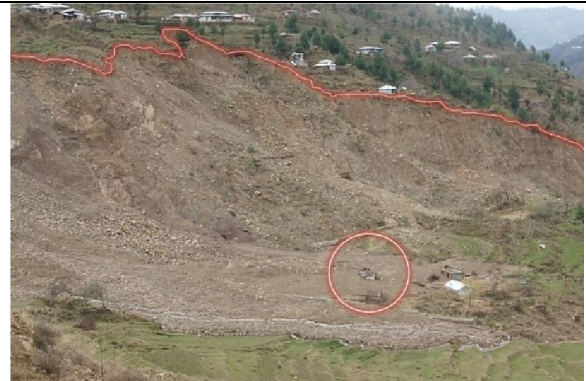
Figure 6. The recent earth flow destroyed three houses at the toe of Karli slide and houses at the scarp are under potential risk.

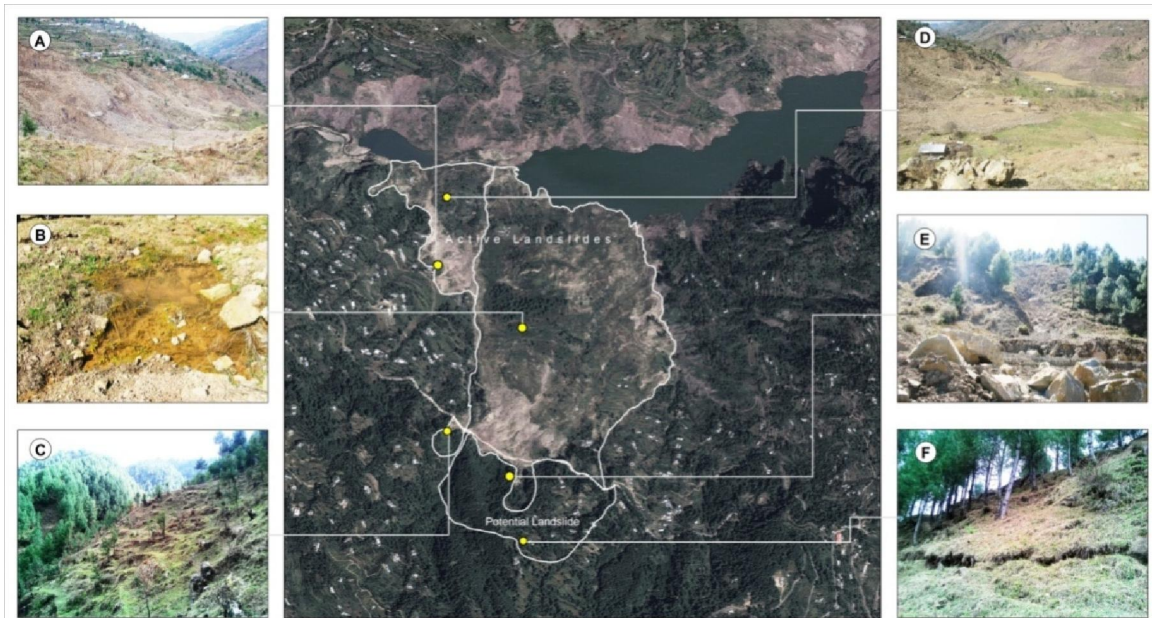
Figure 7. Features of the Karli landslide source and deposit area; a) The houses present at the scarp are under potential threat; b) Presence of pond indicate the potential hazard of flow; c) Deforestation contributed the failure of the main scarp d) Landslide damages to the houses e) View of the landslide main scarp; f) The rupture at the main scarp indicate the potential landslide hazard in future.

Field observation indicate that a sudden breach out of Karli lake would have disturbed the equilibrium conditions. Pore water pressure gradient in the slope would have increased that led to the increase in seepage forces to the threshold that triggered the heavy

landslide (Figure 7a). This hypothesis is supported by the evidences such as presence of seepages and pond in the affected area (Figure 7b). On 24 March 2014, following the heavy rain fall another slide was triggered in the Karli area that moved downward and

transformed rapidly into earthflow (Figures 7c and 7d). The seepages, surface run off and springs played an important role in transforming the clayey material into flow. The subsequent surface runoff and seepages increased the ground water level and saturated the base of the slope that contributed earth flow. The recent earth flow destroyed 3 houses completely and many others at the scarp of slide are under potential threats

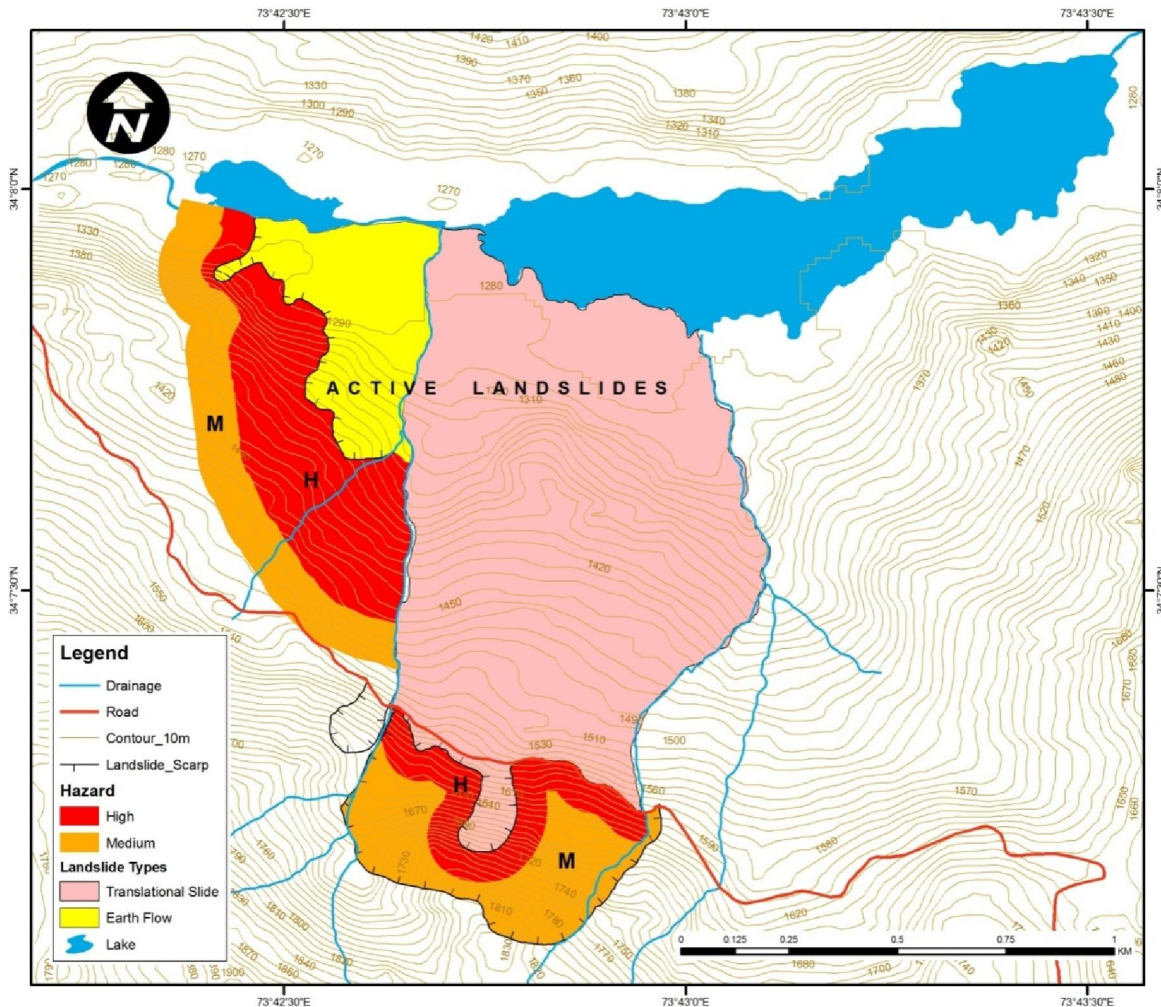
(Figure 8). Two types of landslide hazards were evaluated: deep seated translational slide that occurred in February 2010 and recent earth flow of 2014. Besides aforementioned factors the other factors like the deforestation, surface runoff, shallow ground water, weak underlying material and proximity to the Muzaffarabad Fault also contributed to the Karli landslides.

Figure 8 Map shows the Karli landslide source and deposit area. The Polygons show the boundaries of landslide and buffer indicate the future potential hazard zone of the area.

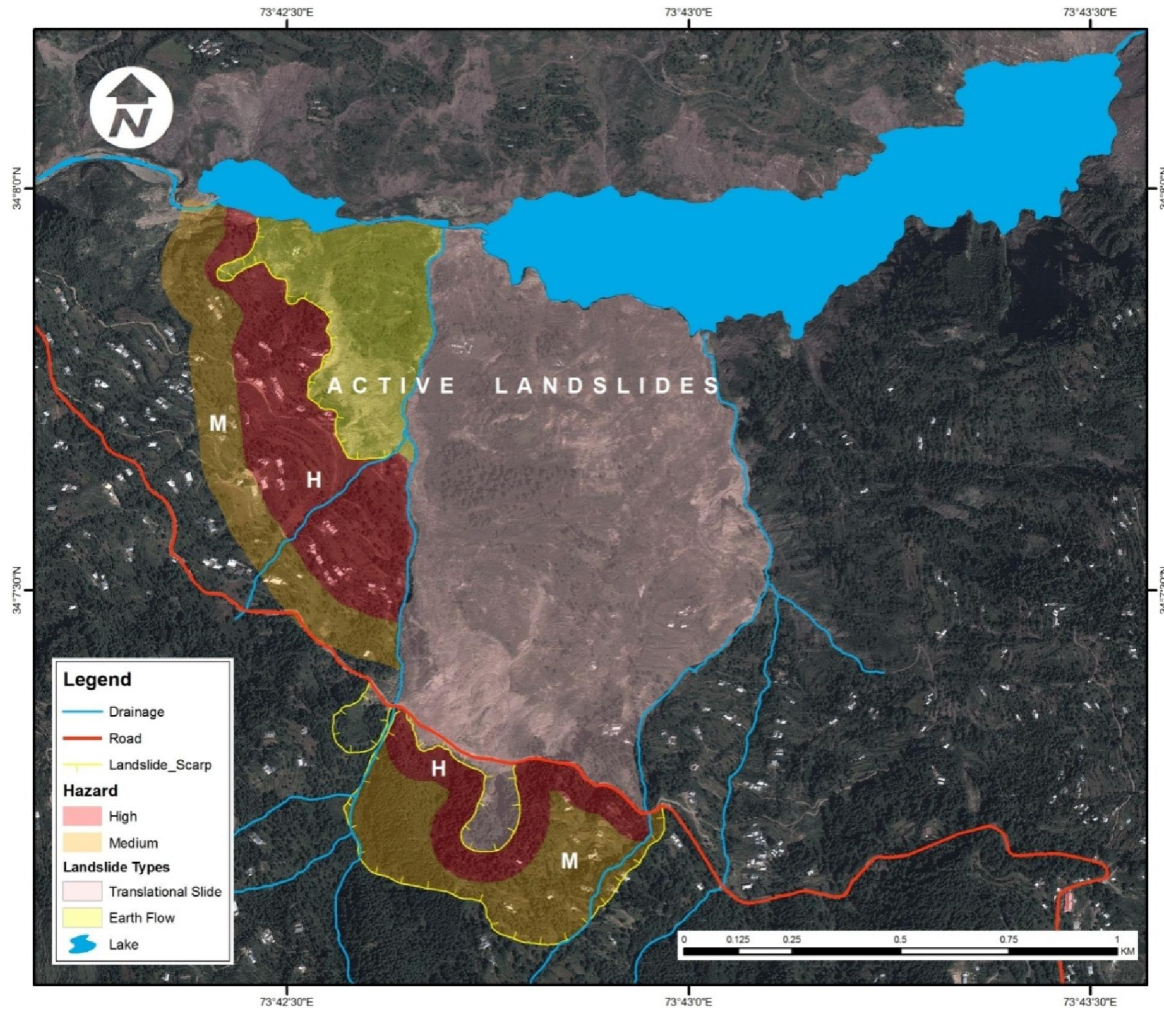
The February 2010 and March 2014 Karli landslide clearly demonstrate the potential for deep translational and rapidly moving earthflow type landslide with significant displacement of the area (Figure 9). Flow type landslides are destructive and threat to life safety due to their velocity and impact. When such type of landslide occurs, the potential

Figure 9. Satellite images showing High and Medium hazard area

threats are loss of life and property damage. In Karli area, both landslides have potential to damage the houses and are future life risk. The affected area being under continuous threat of significant displacement is not recommended for any type of construction. It is therefore timely to relocate the inhabitants of the area to the safer place as soon as possible.
