Investigation of the Damage of Horizontally Curved Precast Prestressed Segmental Bridge

Abstract: A horizontally curved precast segmental bridge collapsed during the prestressing of stitching segment and the two segments around it from each side. The collapse was investigated and the main causes of damage are addressed in details.

Bridge B is one bridge among a series of bridges included in a highway project no. RA-186 in Kuwait. It is a horizontally curved; precast segmental bridge. A damage occurred during the prestressing of the stitching segment and the surrounding two segments from each side. The results of bridge inspection are illustrated. The possible causes of the damages are mentioned and a 3D computer model has been developed to correlate the site observations with

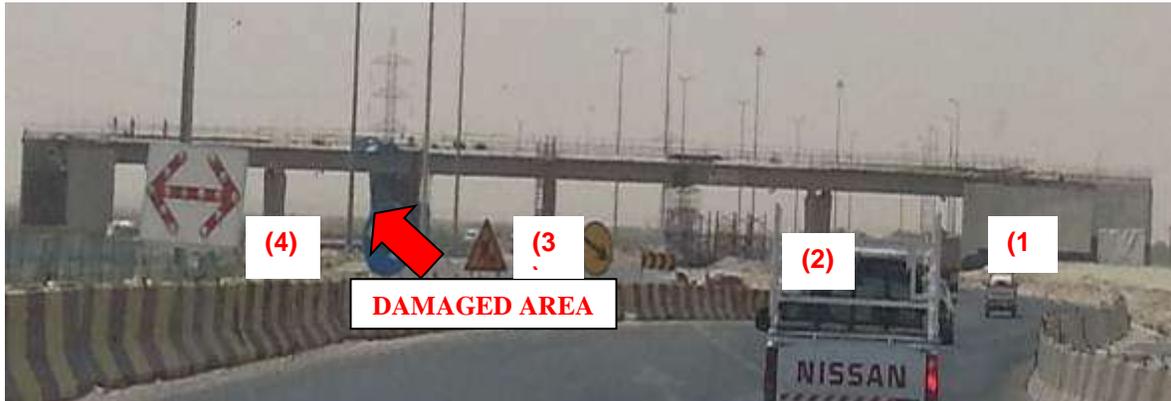
Picture 4 shows a general view of the bridge with the damage located between axis 3 and 4.

Picture 4: General view of Bridge B, showing the location of the damage

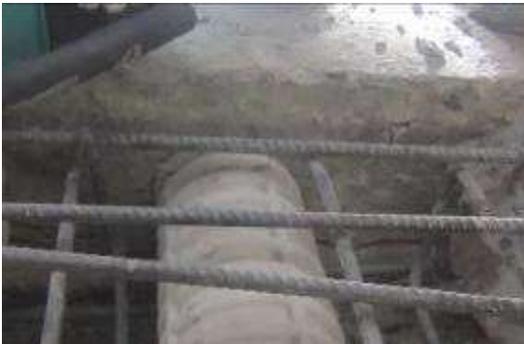
Pictures 5 to 9 show damage of the bottom slab of the closing segment and the first precast segment attached to it towards axis 4. These damages

may be categorized by crushing of concrete, delamination and splitting stresses in the bottom slab.

Picture 5: Splitting of Concrete

In our case, we have a number of curved ducts in one plane, a lack of vertical hair pin around the tendon and along the whole length of tendon resulted in delamination of the concrete of the bottom slabs as shown in pictures 5 to 9. Moreover, the required reinforcement to hold the tendons in place during pouring the concrete has not been considered in the drawings. This was also observed in both the cast in place closing segment and the precast segment as shown in pictures 10 to 12. As a result, these tendons

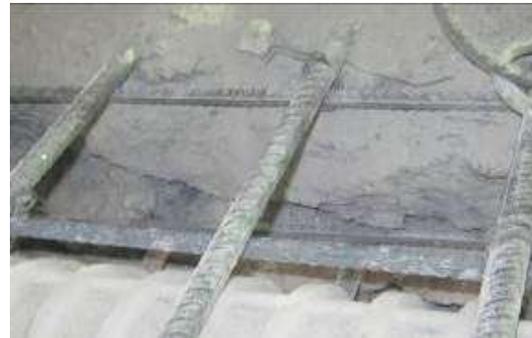
Picture 6: Delamination of concrete

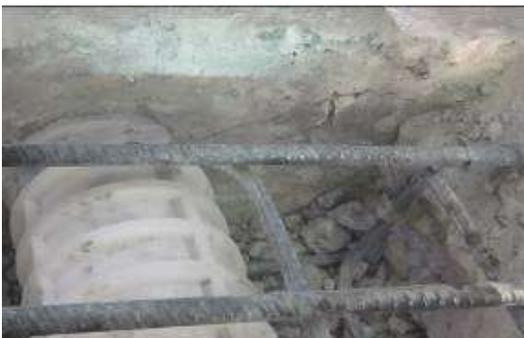
Picture 7: Splitting of concrete

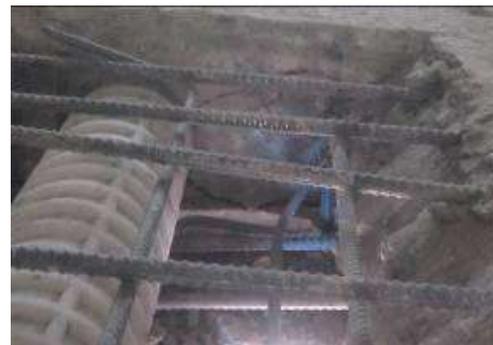
Picture 8: Delamination and crushing of

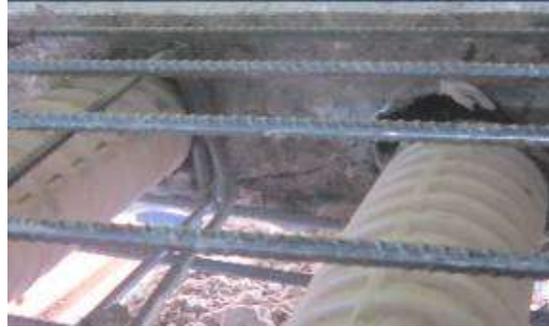
Picture 9: Splitting and out of plane overstresses in the bottom slab

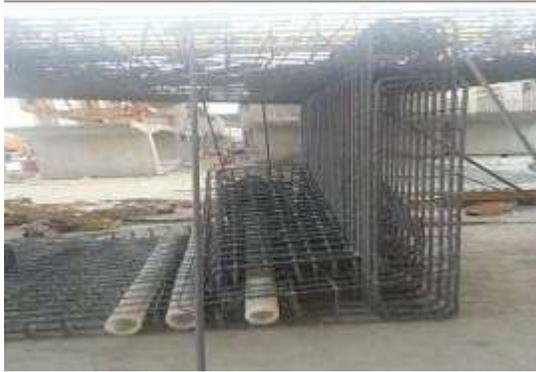
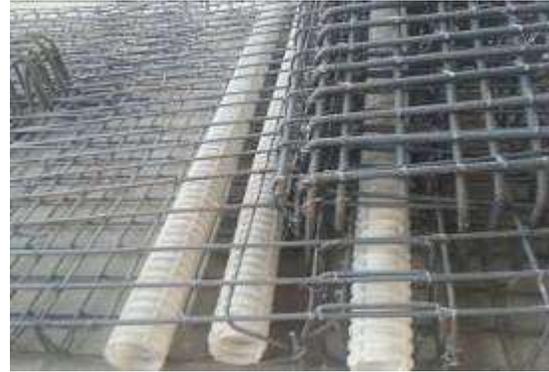
will move from their position due to the concrete pressure resulting in different stresses than shown by calculations.

Pictures 10 and 11: Lack of steel holders in the casting yard

- Lack of holders to keep the ducts in their right location during pouring the concrete.

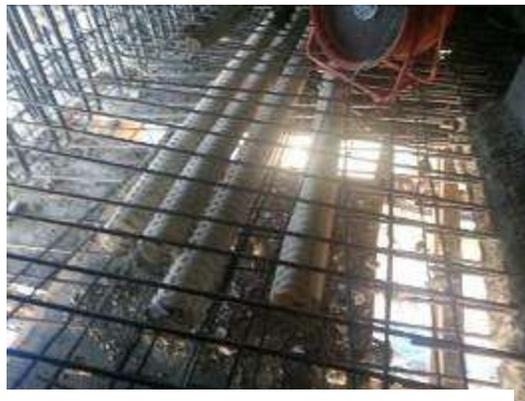
Picture 12: Lack of steel holders in the site

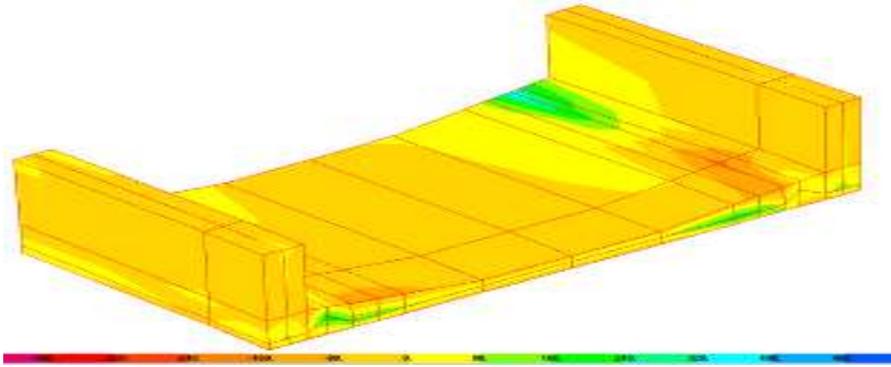
Figure 6: Radial Stress at Middle of Enclosing Segment (normal stress, Y axis)

- Figure 6 illustrates the radial normal stress along Y axis at the bottom flange of the enclosing segment. There is local tensile stress at the damaged area ranges between 160 to 240 Kg/cm². This stress is higher than the capacity of concrete especially with lack of enough reinforcement to withstand this stress.

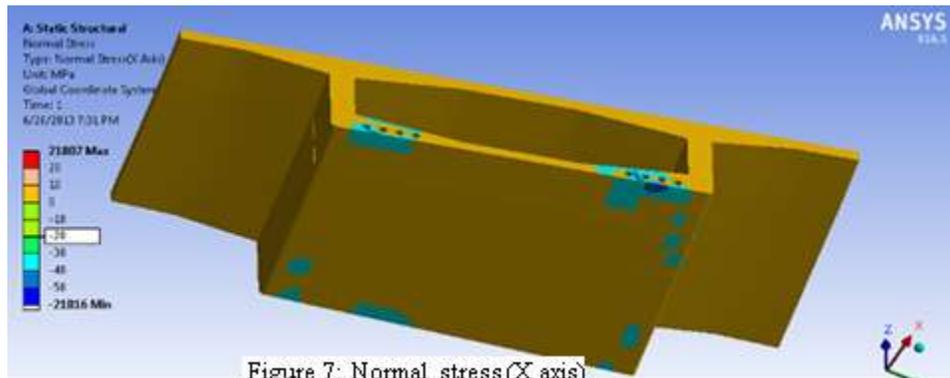
Figure 7: Normal stress (X axis)

- Figure 7 illustrates the distribution of normal stress in x direction. As show in the figure, there is stress concentration at the local area, between the ducts, ranges between 400 to 500 Kg/cm². This value was calculated assuming evenly distributed through the complete box section and the result was 100 Kg/cm². The effect of stress concentration in this narrow zone is much higher than would be expected. This explains the crushing of concrete around the ducts shown in the pictures above, pictures 5 to 9. This stress concentration may be attributed to the big duct diameter to accommodate the remarkable big number of strands at each duct, 31 strands. The effect of stress concentration could have been avoided by using less number of strands, e.g.19, with smaller ducts diameter.

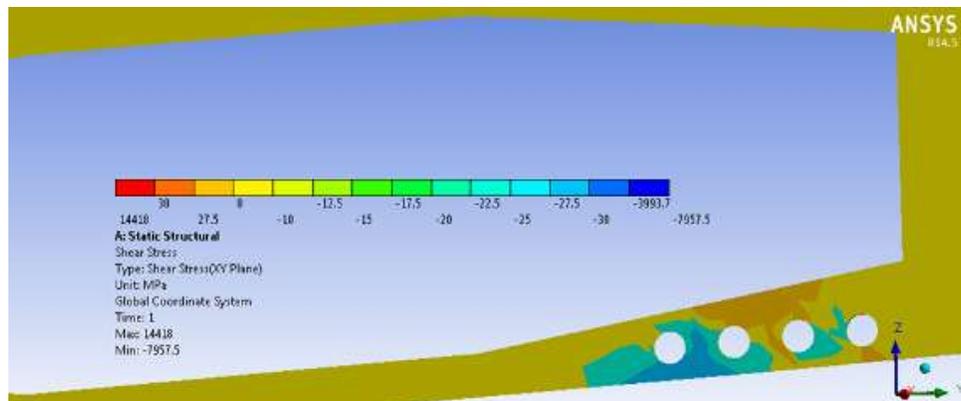
Figure 8: Horizontal shear stress along (X-Y Plan)

- Figure 8 illustrates the distribution of the horizontal shear stress through X-Y plan. The maximum values ranges between 350 and 400 Kg/cm². This value is about 10 times the shear strength of concrete, which justifies the delamination shown in the pictures.
