**Deterioration and Treatment Study of Archaeological Limestone Statues, Sakkara, Egypt**

**Abstract:** Sakkara is one section of the great necropolis of Memphis, the Old Kingdom capital and the kings of the 1<sup>st</sup> Dynasty as well as that of the 2<sup>nd</sup> Dynasty are mostly buried in this section of the Memphis necropolis. A group of Greco-roman limestone statues were found in front of Serapeum tomb entrance which was built at least as early as the 18<sup>th</sup> dynasty. They called "Statues of Philosophies". They suffer from different deterioration phenomena such as missing parts, erosion of stone, presence of cracks and micro cracks, disintegration of some parts, crystallization of salts and dirt. Deterioration factors were different sources of moisture, salts, wind erosion and changes in temperature. Studying phenomena and factors of their deterioration were performed by various investigations and analyses. Stone samples were collected from these statues. Study of these samples have been carried out using polarizing microscope (PLM), scanning electron microscope (SEM), X-ray diffraction (XRD) and energy dispersive X-ray analysis (EDX). Treatment and conservation

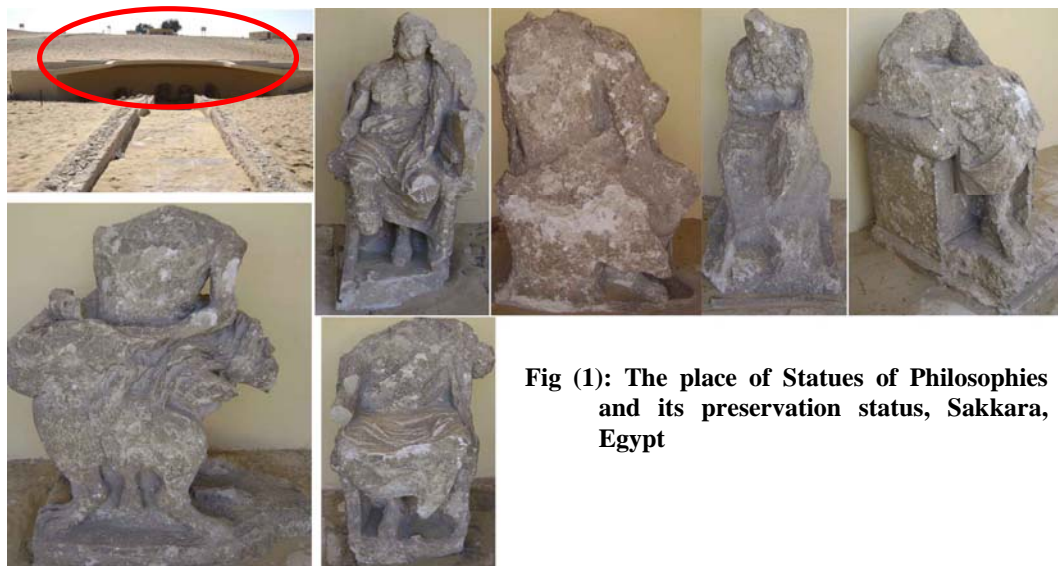
**Fig (1): The place of Statues of Philosophies and its preservation status, Sakkara, Egypt**

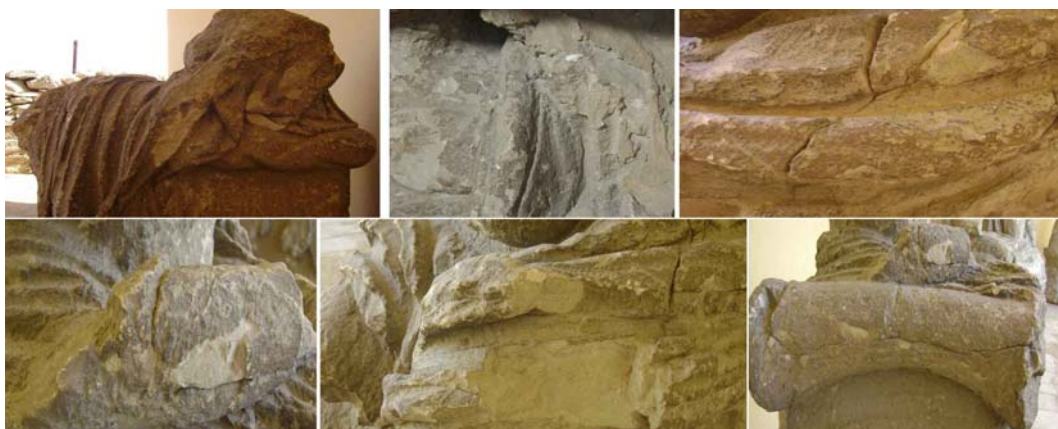
The statues suffer from different deterioration phenomena such as missing parts, erosion of stone surfaces, different type of cracks; macro, micro and wide deep cracks, disintegration of many parts, crystallization of salts and dirt. Deterioration factors were different sources of moisture, salts, wind erosion and changes in temperature and moisture degrees. On the other hand

they suffer from high degradation as the following: high failure, fragile and flaking off due to high moisture and crystallization of salts (Del Monte and

Sabbioni, 1986) in addition to a bad state of their conservation (Fig. 2).

**Fig. (2) Details of deterioration phenomena of the statues as surfaces degradation, crystallization of soluble salts, dark layers on the surfaces, vertical and horizontal deep cracks, erosion by wind effect and missing parts.**

The statues need to carry out different treatments and conservation processes which include cleaning of statues surfaces, removal and extraction of salts, stone in-fill, consolidation and water repellent treatments. These processes will be carried out as follows:

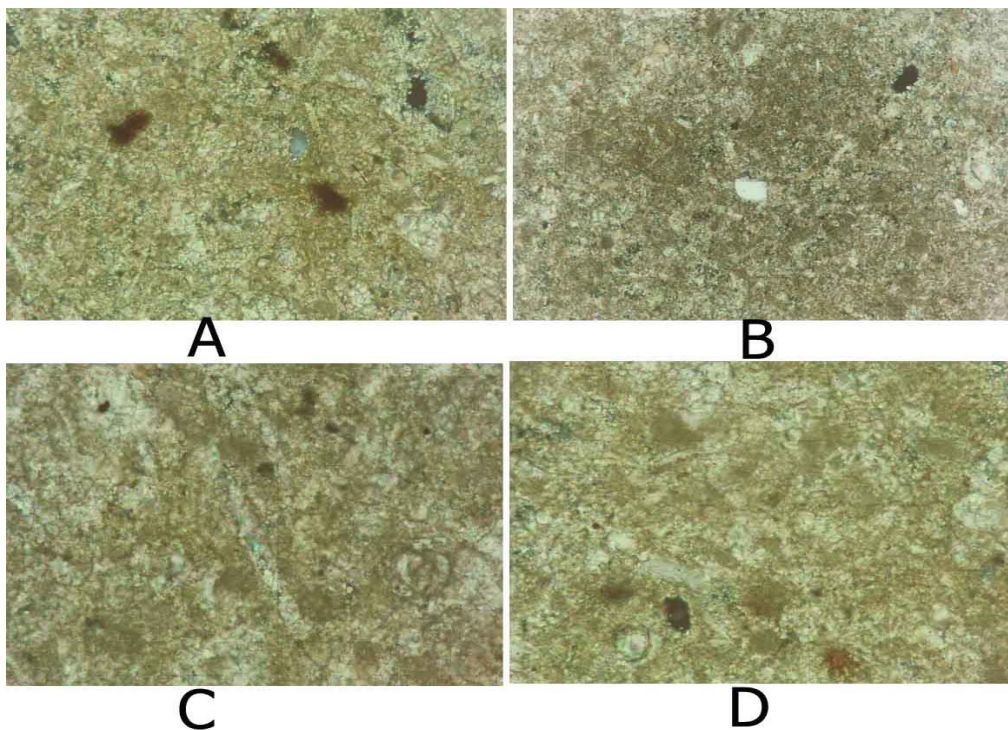
Examination of thin sections of the limestone samples under plan polarised light microscope (PLM) displayed a fine-grained calcite

crystals besides presence of iron oxides, quartz, clay minerals and fossils (Fig. 3). These components increase the rate of stone decay.

**Fig (3. A-D): Shows fine grained calcite (micrite), iron oxides, clay minerals and some fine grained quartz.**

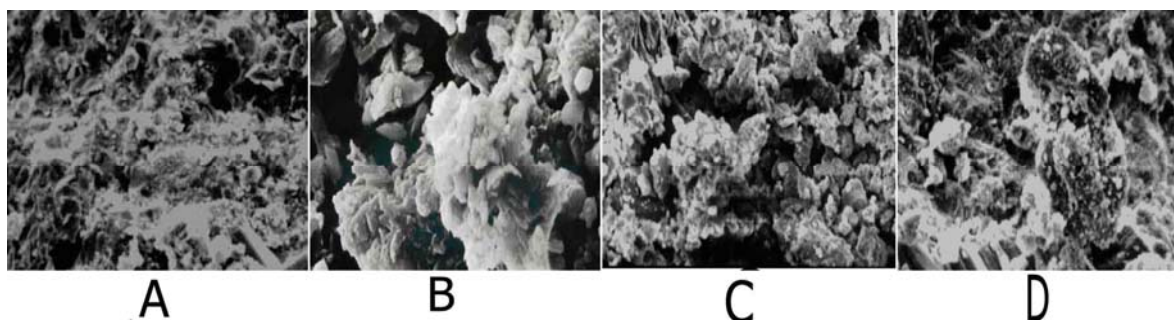
SEM photomicrographs showed disintegration between calcite crystals. Loss in the binding materials between grains by the effect of salts crystallization and erosion by wind effect (Fig 4A-D).

Fig (4A-D): SEM photomicrographs showing the collapse of internal structure (A), voids (B), loose of binding material (C) and salts crystallization between mineral grains of limestone(D).

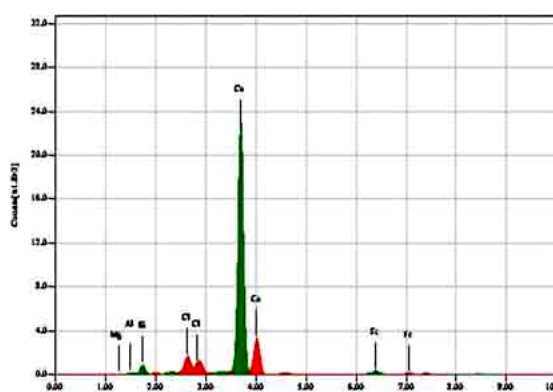
Fig. (5): EDX pattern of limestone sample

EDX analysis was taken of the fresh unpolished cross-section. The cross-section showed the presence of calcite composed mainly of (Ca), (C), and (O). Small amounts of silicon (Si) due to quartz mineral, iron (Fe) related to iron oxides, aluminium (Al) as clay minerals, sodium (Na) and chlorine (Cl) due to presence of halite salt were found (Fig. 5). The moisture can migrate into and within a limestone sculptures in variety ways, depending on whether it is in the liquid or vapor state (Fitzner, et al., 1997) and the transformation of moisture involving variety processes, such as absorption, evaporation, diffusion and capillarity as well as the surface tension of the liquid (Inta, 1996). Furthermore presence of soluble salts within a porous material (Angeli, et al., 2010) such as limestone will increase the amount of water and there are two main mechanisms that responsible for the introduction of soluble salts into the building

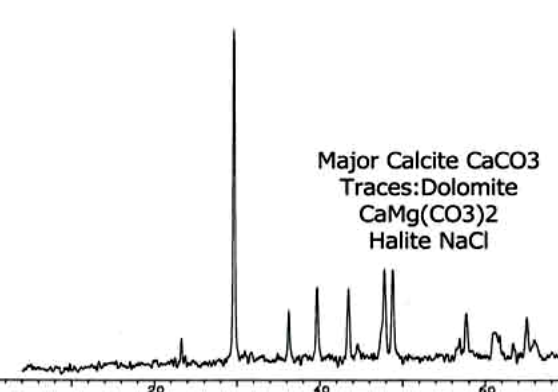
Fig. (6): XRD pattern of limestone sample

The XRD analysis of the yellow limestone sample consists of calcite ( $\text{CaCO}_3$ ) as a major component in addition to dolomite ( $\text{Ca,Mg}(\text{CO}_3)_2$ ), and halite ( $\text{NaCl}$ ) as traces (Fig. 6). Salts can absorb moisture, especially when the relative humidity increases above their equilibrium RH. (Beck, 2010) Then, particularly the very soluble ones may deliquesce (i.e., absorb so much water vapour) that they form a saturated solution. (Charola, 1988) The term "deliquescent" is preferable to "hygroscopic" to describe this phenomenon because it identifies the condition of becoming liquid (Aneta, and Richard, 2010). The actual distribution of moisture within stone depends on porosity, pore-size distribution, and environmental conditions such as changes in temperature and effect of wind with sand. (Garland and Rogers, 1995) As discuss, the maximum of moisture content resulting from wet-dry cycling is closer to the surface in denser stones, deeper and
