**Behavior of R.C Columns with Poor Concrete Strength at Upper Part**

[M. Rabie. **Behavior of R.C Columns with Poor Concrete Strength at Upper Part.** Life Sci J 2012; 9(2):1159-1165]. (ISSN: 1097-8135). <http://www.lifesciencesite.com>. 173

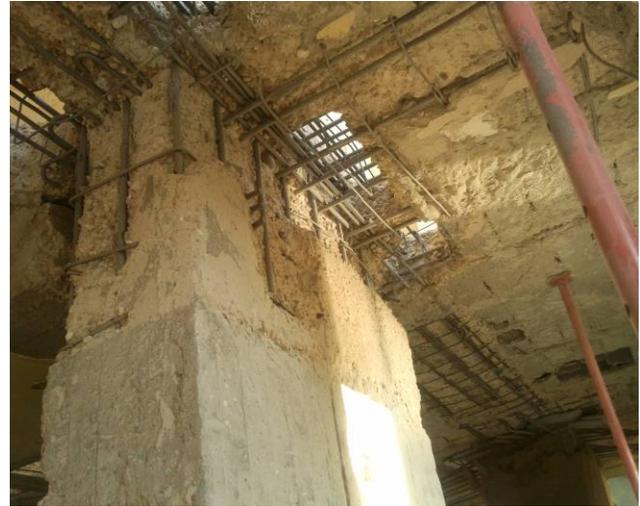
**Fig. (1) Bad quality concrete at upper part of column**

A lot of previous researches focused on the behavior of column with constant strength along its full height, even if there is a local defect in the column. In the present study the construction deficiencies such as bad quality concrete at upper part of column are precisely considered as shown in figure (1).

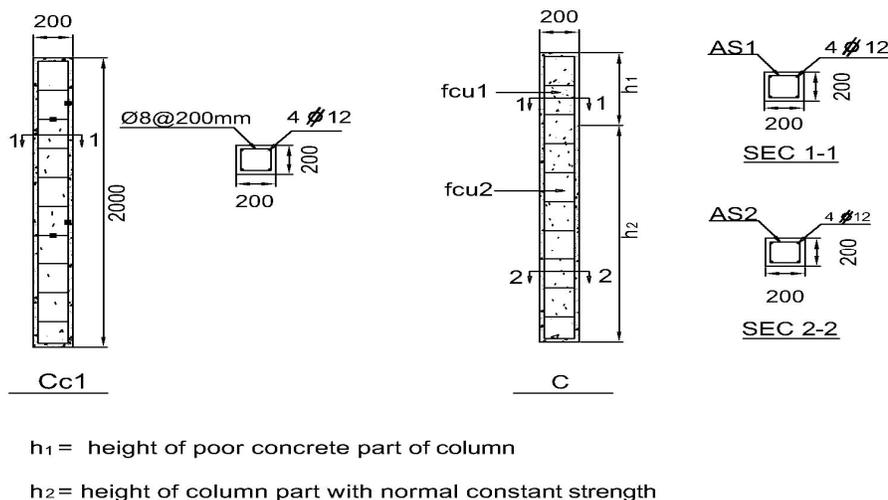
**Fig (2) test specimens details**

Twelve  $200 \times 200 \times 2000$  mm rectangular columns of concrete strength ( $f_{cu}$ ) 40 MPa were cast and tested. The main variables of the studied parameters were the upper poor concrete strength (12.5 – 20) MPa, the spacing of stirrups (200 -100 mm), and the stirrups diameter (8-10 mm). (36/52) steel grade was used for longitudinal reinforcement (diameter of 12 mm). The details of the specimens are as given in Figure (2). The columns were cast vertically to simulate the columns in actual practice of construction and compacted with a needle vibrator. Instrumentation, casting, and curing are shown in figures (3, 4, 5). Also the tested specimens properties are given in table (1).

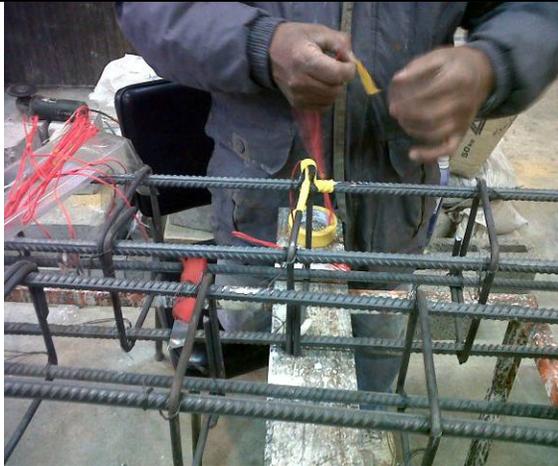
Fig. (3) Fixing electrical strain gages

Concrete strains were measured by mechanical strain gauges of 100 mm gauge length, using demic points mounted on the upper and lower columns' sides at the same positions in all columns. Also, electric strain gauges are fixed on longitudinal steel bars and transversal stirrups.

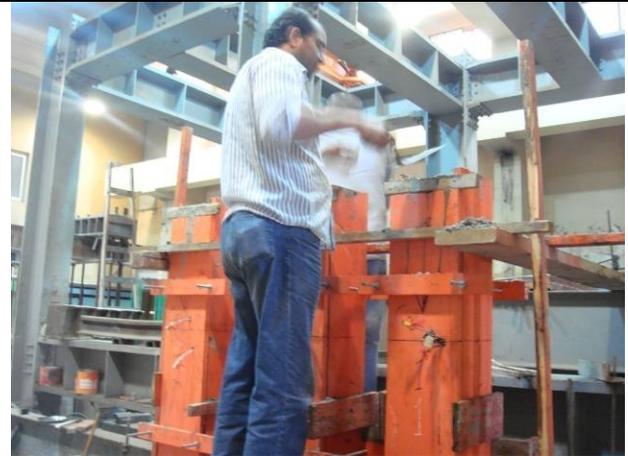
Fig. (4) Specimens casting

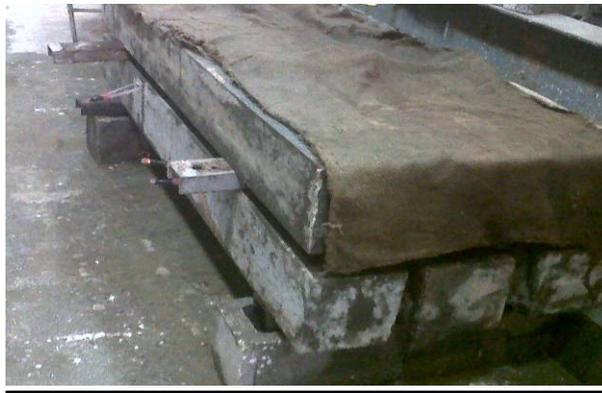
Fig. (5) Specimens curing

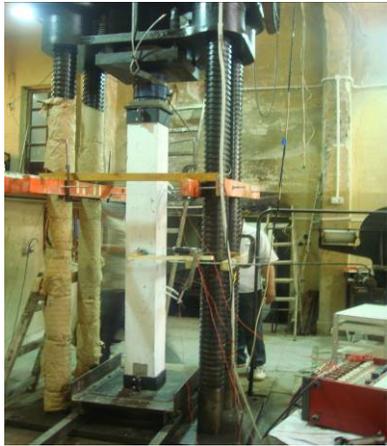
Fig. (6) Set up of loading of the tested columns

All columns were loaded with 500 ton hydraulic machine in Cairo university concrete research lab. The applied load was read out on the load cell scale. The set up of loading of the tested columns is shown in figure (6). To ensure concentric loading; displacement dial gauges of 0.01 mm accuracy and LVDT were placed at upper and middle position along column two

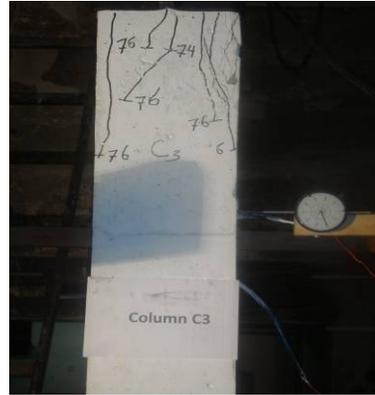
Fig. (7) Location of dial gauges and LVDT at upper and middle position along column

perpendicular sides to monitor its deflected shape at different increments of loading as shown in fig. (7).

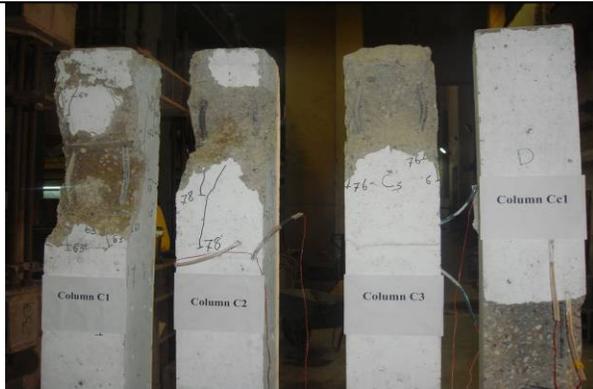
Fig. (8) crack pattern and the shape of failure of c1, c2, c3

For the twelve tested columns, the first crack appeared at a load level about 70% to 80 % of the ultimate (the failure) load for upper poor concrete strength specimens. While it was appeared at a load level about 80% to 90 % of the ultimate (the failure) load for control specimen of normal concrete strength, table (2) shows the value of loads at which the first crack appeared at upper part for each column. In addition; figures (8) to (10) show the crack pattern and the shape of failure of the tested columns.

1. Mode of failure of all poor concrete upper part tested specimens was the initiation of vertical crack at upper part followed by crushing of concrete at top of column. While horizontal and vertical cracks appear at middle of normal concrete strength control specimen.

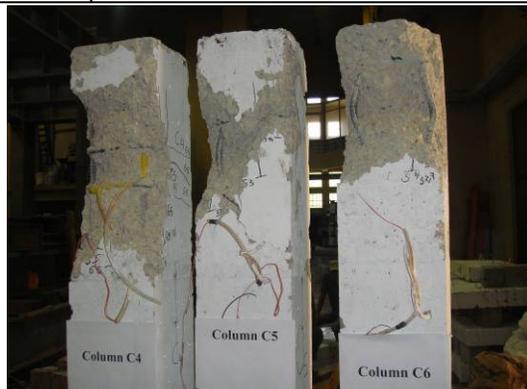
Fig. (9) crack pattern and the shape of failure of c4 , c5 , c6

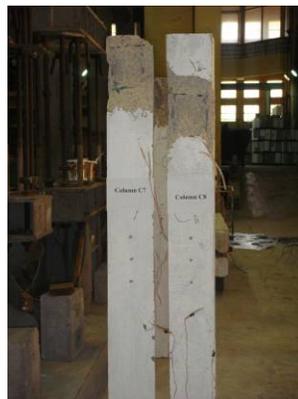
Fig. (10) crack pattern and the shape of failure of c7 , c8

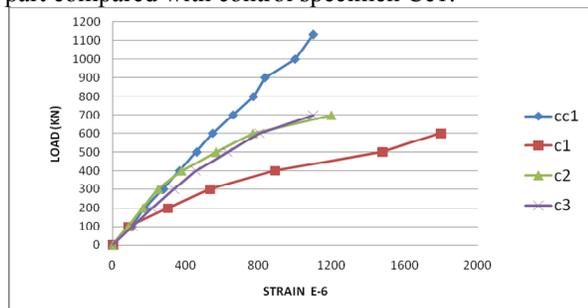
**Fig. (11) Load - Vertical Concrete Compressive Strain of Upper Part**

Figures (11, 12) illustrate that the ultimate load decreased by about 45,31 and 30% in specimens C1, C2, and C3 as the concrete strengths in the upper part of the column were 14, 18, and 20 MPa respectively compared with the control specimen of constant concrete strength of 40 MPa. While the column longitudinal strain at the same ultimate load decreased in lower portion of column with normal strength concrete compared with upper poor strength concrete part.

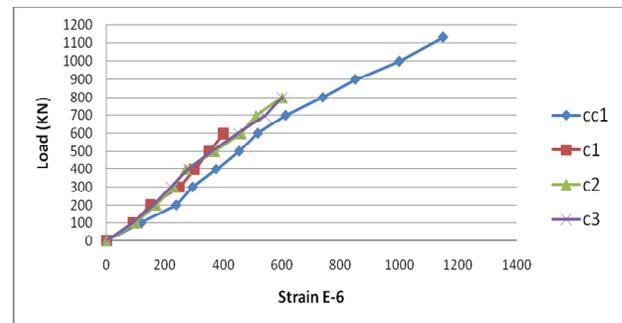
**Fig. (12) Load - Vertical Concrete Compressive Strain of Lower Part**

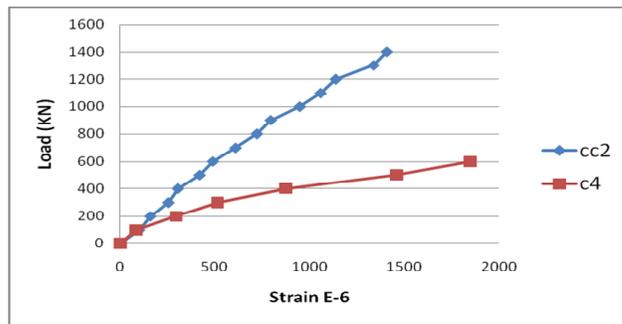
**Fig. (13) Load - Vertical Concrete Compressive Strain of Upper Part**

Figures ( 13 , 14 , 15 ) showed that the effect of decreasing the spacing between stirrups or increasing its diameter in the upper poor concrete strength part of the specimens C4 , C5 ,and C6 had little effect on measured ultimate load. While, this effect was increased in control specimens Cc2, Cc3, and Cc4.

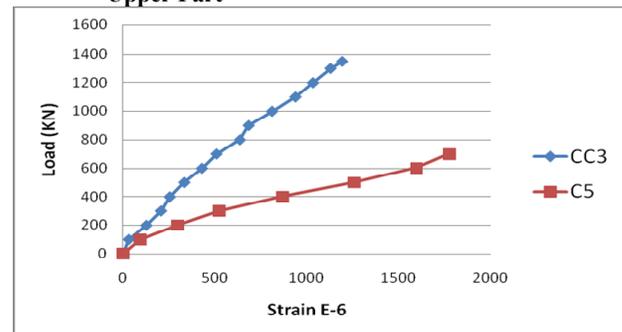
**Fig. (14) Load - Vertical Concrete Compressive Strain of Upper Part**

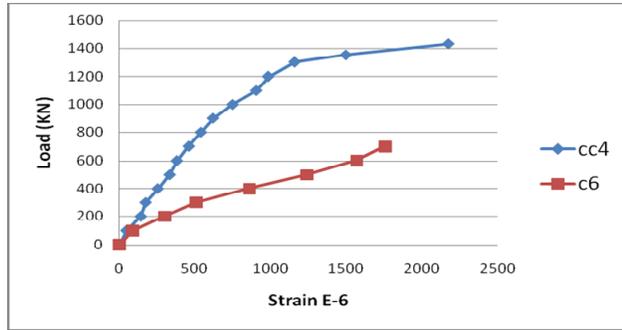
Fig. (15) Load - Vertical Concrete Compressive Strain of Upper Part

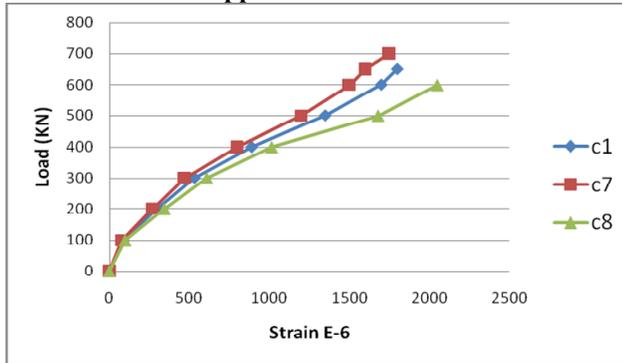
Fig. (16) Load - Vertical Concrete Compressive Strain of Upper Part

Figure (16) showed that the height decreasing of upper poor concrete strength (h1) of specimens C7 by about 30% increased the ultimate load by about 14% compared with tested specimen C1. While the height increasing of upper poor concrete strength (h1) of specimens C8 by about 30% decreased the ultimate load by about 4% compared with tested specimen C1.

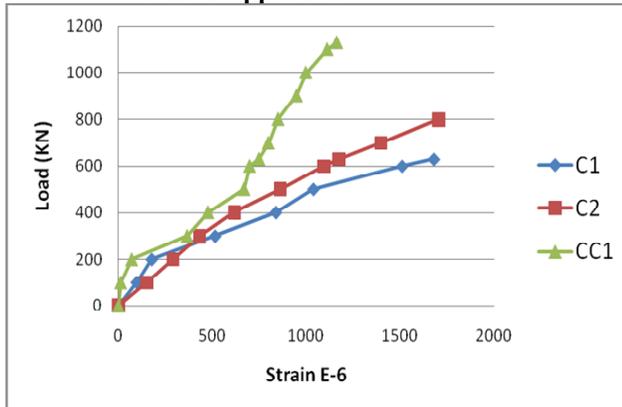
Fig. (17) Load - Vertical Steel Compressive Strain of Upper Part

Figures (17, 18) illustrate that longitudinal steel – strains in upper poor concrete part of specimens C1 and C2 was more than that of lower normal concrete part. Also longitudinal steel – strain increased in upper part compared with control specimen Cc1.

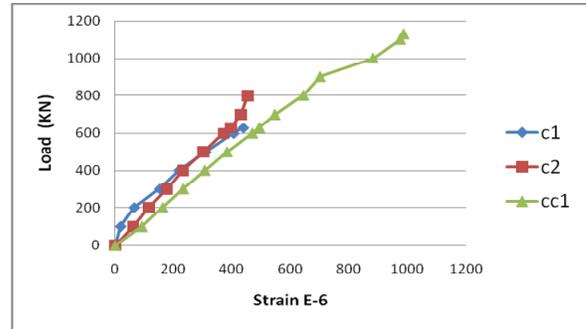
Fig. (18) Load - Vertical Steel Compressive Strain of Bottom Part

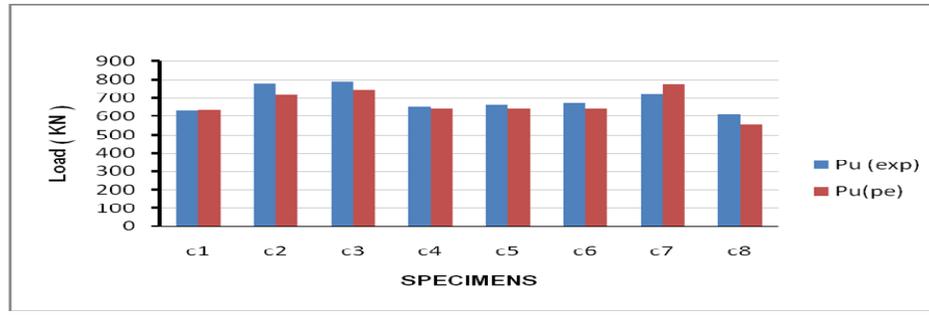
Fig. ( 19 ) comparison between  $P_u$  (exp) and  $P_u$ (pe)

Table (3) and figure ( 19 ) showed good agreement between experimental measured ultimate load and the calculated one using the proposed equation.
