Investigation of the Damage of Horizontally Curved Precast Prestressed Segmental Bridge

Abstract: A horizontally curved precast segmental bridge collapsed during the prestressing of stitching segment and the two segments around it from each side. The collapse was investigated and the main causes of damage are addressed in details.

Bridge B is one bridge among a series of bridges included in a highway project no. RA-186 in Kuwait. It is a horizontally curved; precast segmental bridge. A damage occurred during the prestressing of the stitching segment and the surrounding two segments from each side. The results of bridge inspection are illustrated. The possible causes of the damages are mentioned and a 3D computer model has been developed to correlate the site observations with

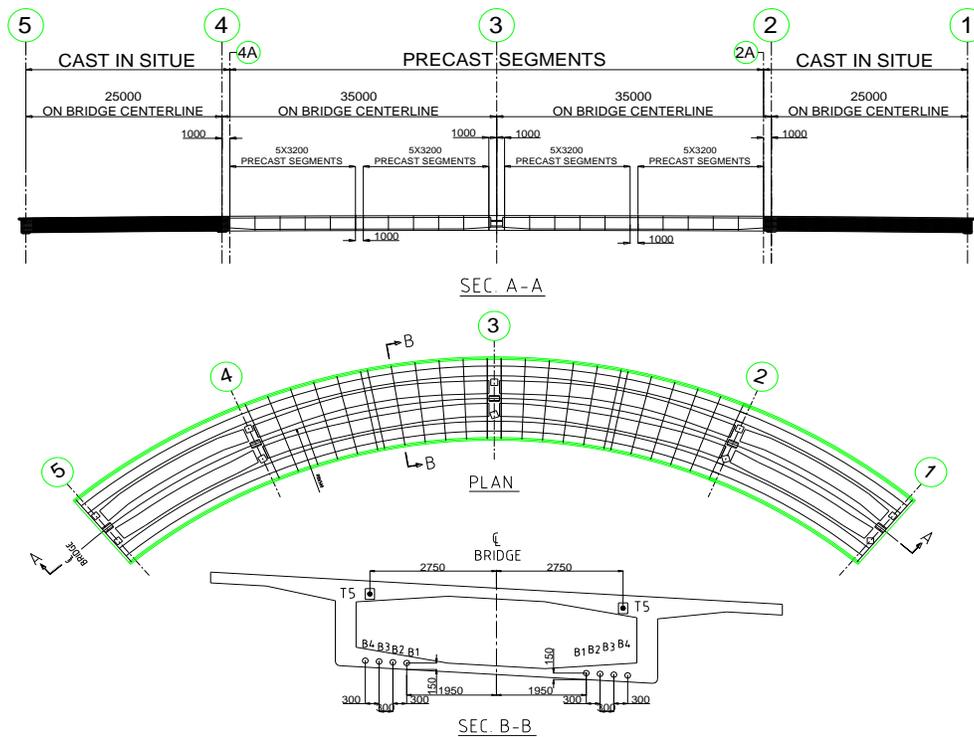
Figure 1: Details of Bridge Deck and Sequence of construction

The bridge deck consists of 4 spans from axis 01 to 05. Figure 1 illustrates the construction method of the bridge. Span 01-02 is cast in situ with a cantilever extending after axis 02 to 02A. Span 05-04 is cast in situ with a cantilever extending after axis 04 to 04A. The remaining part from 02A to 04A is segmental precast units. The deck is supported by Pot bearings with different restraints from axis 01 to axis 05.

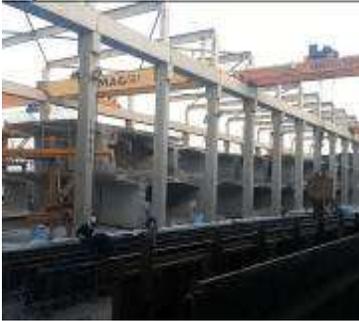
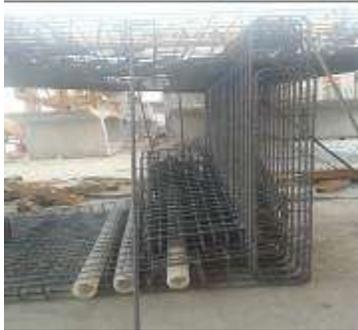
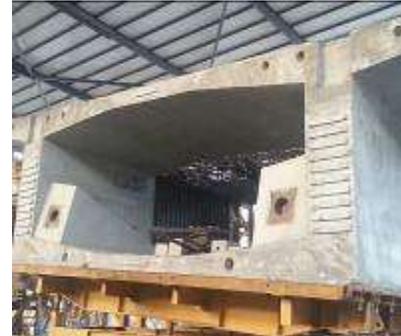
Pictures 1 to 3: Casting Yard

- a- The casting yard of the precast units has been visited. Pictures 1 to 3 show some views inside the casting yard.
- b- The bridge was inspected, and the observations of this visit were coordinated with the pictures received from different sources.

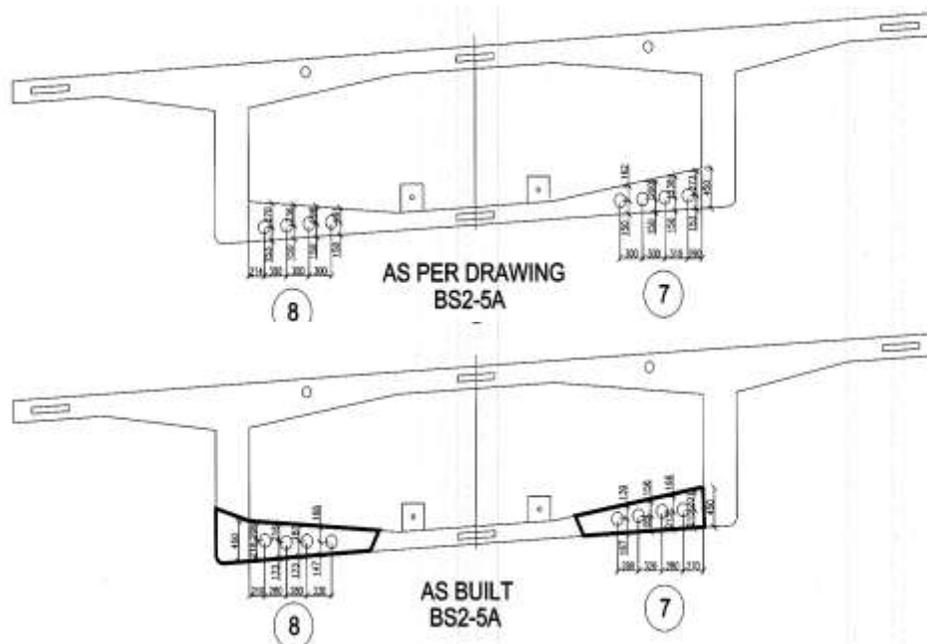
Figure 2: Deviation of tendons

- e- The details shown in the different drawings were compared to the requirements of AASHTO LRFD,[1], the specifications of the project.
- f- Detailed computer analysis was prepared considering the three construction stages shown in the design drawings. The tendons were allocated considering the deviations explained to us during our visit and submitted in sketches. Figure 2 shows one of these sketches.

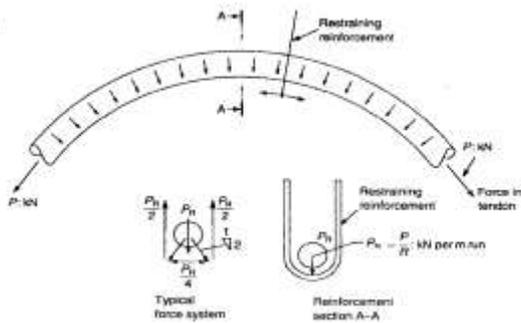
Figure 3: In Plan Radial Force (F/R)

perpendicular to the plane of tendon curvature caused by spreading of the strands within the duct, [1, 4, 5]. Generally speaking, curved tendons, exerts a pressure on the concrete causing splitting forces that must be considered in the design by adding special reinforcement. Moreover, the risk increases when curved tendons run parallel to each other in the plane of curvature, which is our case. The parallel curved tendons cause bursting force into the adjacent duct. Figures 3 and 4 illustrate the in plane and out of plane forces.

Without adequate reinforcement, the tendon radial forces may rip through the concrete cover or unbalanced compressive forces may push off the concrete on the outside of the curve, [6].

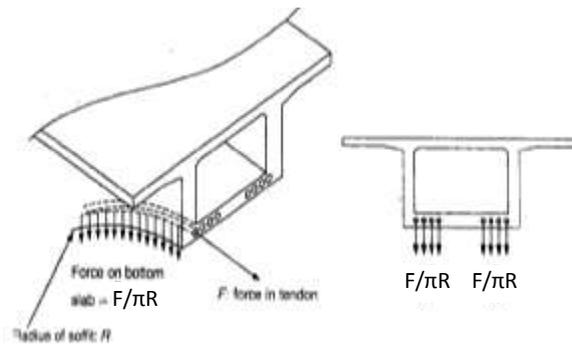
Figure 4: Out of Plan forces ($F/\pi R$)

In our case, we have a number of curved ducts in one plane, a lack of vertical hair pin around the tendon and along the whole length of tendon resulted in delamination of the concrete of the bottom slabs as shown in pictures 5 to 9. Moreover, the required reinforcement to hold the tendons in place during pouring the concrete has not been considered in the drawings. This was also observed in both the cast in place closing segment and the precast segment as shown in pictures 10 to 12. As a result, these tendons

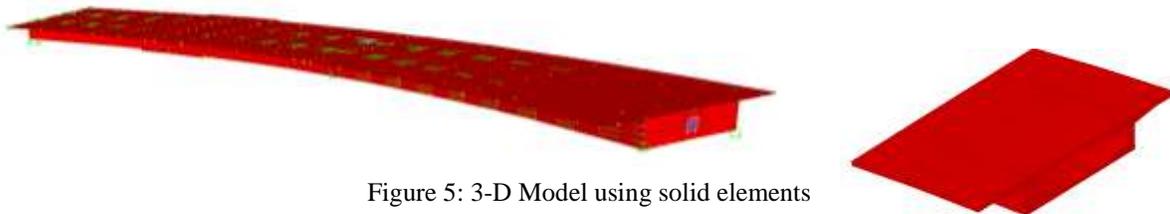
Figure 5: 3-D Model using solid elements

objective of this computer model is to study the stresses resulting in the local zone of damage. The bridge was modeled using solid elements as shown in figure 5, [3].
