# Evaluation of Actual Field Ageing on Silicone Rubber Insulator under Coastal Environment

**Abstract:** Insulators in the field experience synergistic effects of temperature, UV radiation, rain, clear mist, and contamination. One of the problems related to outdoor polymeric insulator is erosion and tracking of the weathershed which can affect the reliability of power system. This paper presents investigations on the performance of outdoor 63 kV silicone rubber insulators after seven years of field exposure. The insulator performances were evaluated in laboratory by measurements of leakage currents under clean fog and salt fog conditions. Also visual inspection, hydrophobicity classification and material diagnostic technique have been used to detect defective in service silicone rubber insulators. The polymer content of some surface regions decreased as degradation increased. Scanning electron microscopy, Thermo-Gravimetric, attenuated total reflectance-Fourier transform infrared spectroscopy analysis and energy dispersive x-ray analysis used to identify the elemental composition of virgin and aged surface of insulator. Peak values of leakage current and cumulative charge are meas

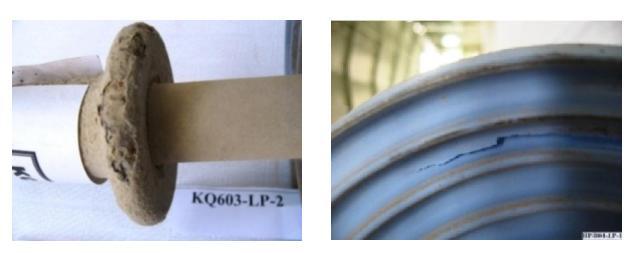
Figure 1-Visual observation after 7 years

A visual inspection revealed that all the samples presented small cracks and in their polymer sheath, corrosion and oxidation in the end fitting, especially in the live fitting. By looking at the insulators, no significant surface changes were found on the insulators and that was seen that the color of the surface compared to the virgin sample changed. Figure (1) shows the picture of insulator after 7 years.

The cracks in the polymer sheath are a risk factor. It is impossible to predict how long it will be before water penetrate between the rod and sheath, and how much time it will take for this to cause insulator failure. So, evaluation and regarding the state of polymer insulators is one of the important preventive affairs which increase the life time of insulator and reliability of transmission and distribution system. Material test released that the number of methyl groups at the SiR surface is reduced by the treatment, as shown by XPS and FTIR-ATR evidence. The aged sample has the highest porosity and roughness of all the samples. The hydroxyl and carboxyl groups were formed when Si-CH<sub>3</sub> and C-H were broken by ageing. The results obtained demonstrate that the hydrophobicity of polymer insulator was found to decrease with ageing and was attributed to formation of carbonyl groups and loss of methyl groups on surface of polymer. Electrical Test results show that the insulators were still in good condition and there was no major degradation observed in 7years

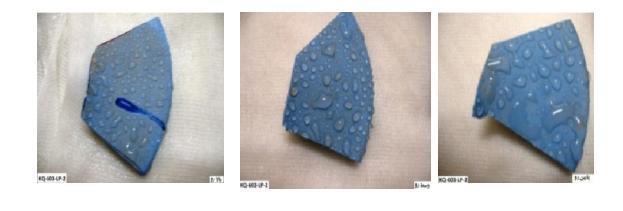
Figure 3. Hydrophobicity picture of aged sample: a) top shed (HC1-HC2), b) Middle shed (HC3), c) energized shed (HC4)

Amount of distilled water was squeezed several times on the surface of insulator. Figure (3) shows pictures of SiR insulator. Comparing pictures of figures concludes that the hydrophobicity of the samples after ageing is between HC1 and HC4 categories. It can be seen that the energized shed has the hydrophilic surface.

In order to analyze the ageing effect on the hydrophobicity of the insulators, the Swedish Transmission Research Institute (STRI) method is applied (STRI Guide, 1992). This method classifies the hydrophobicity of surfaces to seven Hydrophobicity Categories, HC1 to HC7. The HC1 refers to the highest surface hydrophobicity while HC7 represents the lowest hydrophobicity.

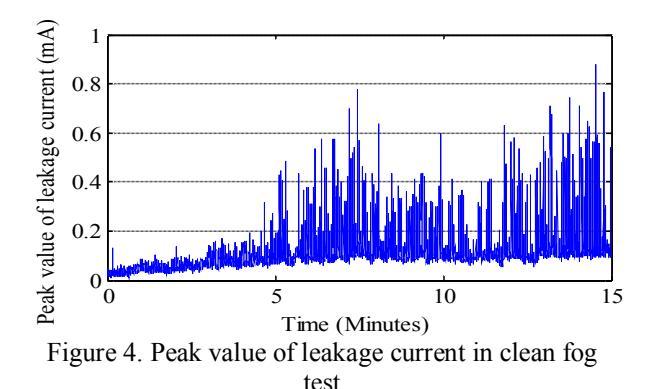
The peak value of leakage currents on the test samples were continuously monitored by the leakage current measuring system which measures and stores the positive and negative cumulated charge with values of 4.2 and 12.1 colon respectively. The volume power losses were measured equals to 0.82 W. Figure (4) show the Peak value of leakage current in clean fog test.

The test insulator was suspended vertically inside the fog chamber (1.5 m x 1.5 m x 1.5 m). The test voltage was 18 kVrms, 50 Hz. The leakage current was measured through a series resistance in the ground lead. A 2 kSa/sec sampling rate data acquisition system was used in this paper. A continuous flow of pure de-ionized water was used to generate fog in the chamber. The fog generation rate was 3 L/(hours). The particle size of the fog was approximately 7  $\mu$ m. The conductivity of the deionized water was 0.005 S/m. The samples were put into the fog chamber for 15 minutes. Fog generation and data acquisition were started simultaneously.

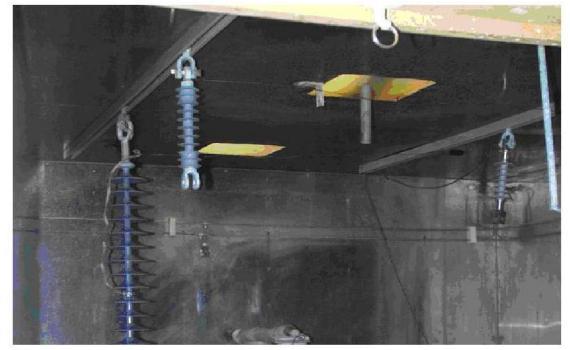
Figure 5. Salt fog chamber after 1000 hours test

The test insulator was suspended vertically inside the fog chamber (1.5 m x 1.5 m x 1.5 m), (Figure 5). The applied test voltage is determined by dividing the actual creepage distance in millimeters by 34.6. So, the applied test voltage (19.5 kV) was adjusted according to the actual creepage distance of 680 mm (IEC 62217, 2005).

The formal test criteria are no more than three over current trip for each specimen test and no tracking, erosion does not reach the glass-fibre core, and sheds are not punctured. There was no surface discharge during the 1000 hours.

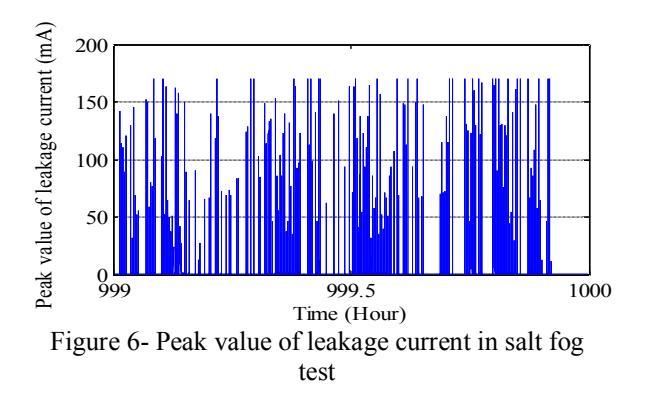
Table (3) shows the experimental conditions of the salt fog ageing test according to the (IEC 61109, 2008). Figure (6) shows the peak value of leakage current in the last hours of salt fog test.

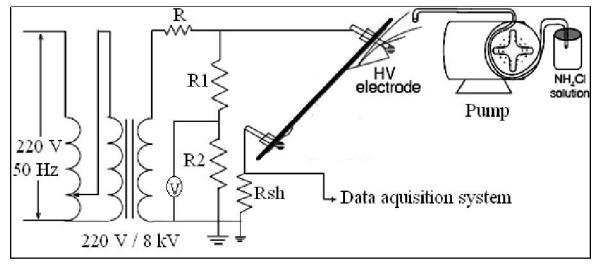
Figure 7. Schematic setup of tracking and erosion resistance test

The experimental set up is shown in figure (7). R is a current limiting resistor and resistors R1 and R2 are voltage divider which is used to measure the output voltage of the 220 V/ 8 kV transformer. Resistor (Rsh) is used to measure the leakage current. For each test an average of 5 samples were subjected to the IP test. A computer data acquisition system was used to record the leakage current and voltage across each specimen separately. The leakage current is passed through a 33 k $\Omega$  shunt resistor. Eroded material from each sample is removed completely with a soft brush. The test electrodes are used only once because of severe ablation during the test. Before the test, all the specimens were washed with distilled water and cleaned with isopropyl alcohol.

According to (IEC 60587, 2007), four different test voltage levels specify; 2.5, 3.5, 4.5 and 6 kV (r.m.s) ac voltage and the flow rates corresponding to the test voltage levels are 0.15, 0.3, 0.6 and 0.6 mL/min respectively. In this present experiment, the test voltage has been fixed at 4.5 kV (r.m.s) for 6 h, the reason to choose this voltage level is that it is the most critical as arcing tended to concentrate at one or two points where it caused severe damage in the form

of extensive erosion. Conductivity of NH4Cl solution used is 2.5 mS/cm.

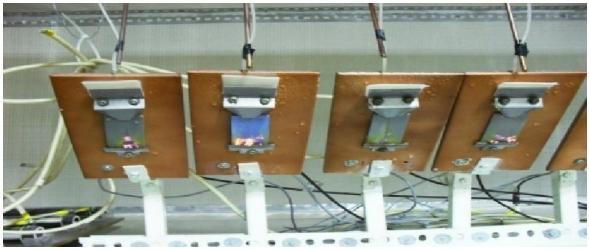
Figure 8. Samples during the IPT

The end point is reached when the value of the current in the high voltage circuit through the specimen exceeds 60 mA or the track reaches a mark on the specimen surface 25 mm from the lower electrode. There was no problem in this test and it passed the test successfully. Figure (8) shows the samples during the test.

To characterize the damage, the damaged volume in each sample was measured by means of suitable mass and all weight measurements were done using a standard measurement with a least count of 0.1 mm. Weight of samples before and after the test were 11.08 and 11.065 respectively.

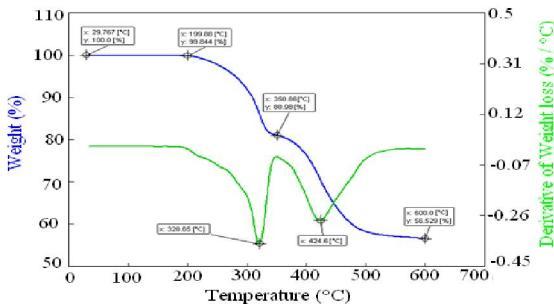
Figure 9. TGA and DTG curves for virgin sample

for both aged and virgin silicone composites .The temperature is increased from 25 to 600 °C. Figs. 9 and 10 show the TGA and Derivative Thermo-Gravimetric (DTG) curves of SiR insulator samples. The samples are chosen after separating the SiR layers from the insulator surface. It can be observed that increasing temperature up to ~190 °C does not affect on samples' weight. Figures show that over 190 °C all samples decompose at two stages. The first is due to the conversion of ATH to Al2O3. During this reaction, water is released. Also it has been found that evaporation of LMWS species can be started at this stage (Ahmadi-Joneidi et al. 2013).

It can be seen that temperature of First drop in aged and virgin sample are 196.19°C and 199.88°C. The second weight loss belongs to the degradation of silicone rubber in forms of LMWS, cross-linked silicone elastomer, and silica. It can be observed that temperature of second drop in aged and virgin sample are 345.53°C and 350.86°C respectively.

First drop in the sample weights is not major and Water started to be detected when the weight loss began at just over 190 °C. It ended at the same time when the first weight loss finished. However, the second drop is caused by the break of the side chain (CH3) from the Si backbone (Si-O-Si). At the end, only a non-volatile residue remains. Residual ash in aged sample was 60.52% and in virgin sample was 56.53%.

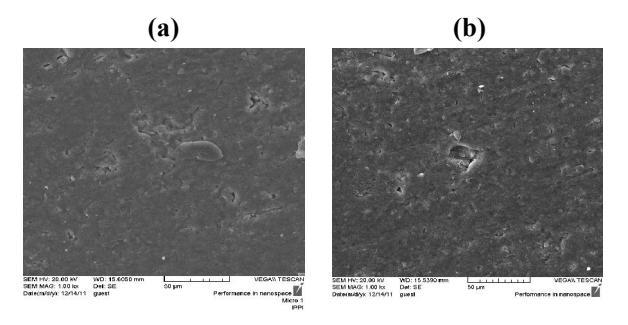
Figure 11. SEM analysis on the surface of samples, (a) virgin, b) aged sample

Figure (11) shows the micrographs for virgin and aged samples at 1000x. The overall observation is that there is no major degradation, such as cracking; also the virgin sample has a smooth, more homogeneous and less porous surface while the surface roughness and porosity increases with ageing for aged SiR Insulators.

An analysis of the surfaces using SEM shows the molecular structural changes of the surface of the silicone rubber. The specimen size was  $1x1x 0.2 \text{ cm}^3$ approximately.

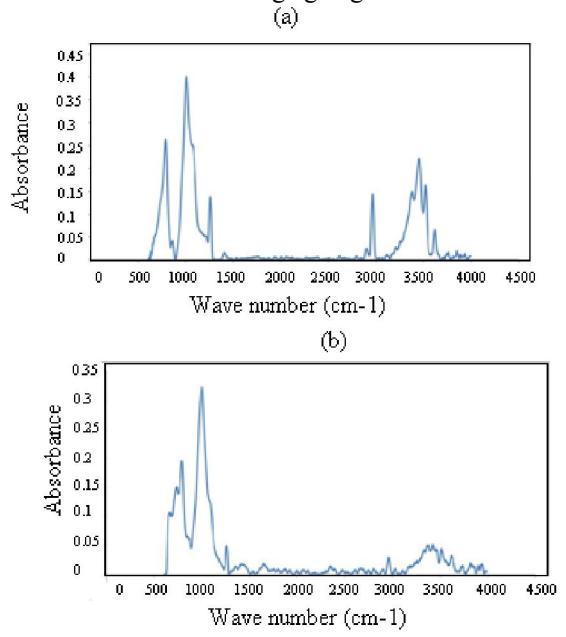
Figure 12. FTIR analysis a) virgin sample, b) aged sample

Figure (12) shows ATR-FTIR absorption spectra as a function of time before and after ageing. The absorbance peaks at 3570 and 3670 cm-1 (O–H), 2960 cm-1 (C-H in CH3), 1260 cm-1 (Si–CH3), 1015 cm-1 (Si-O-Si), and 795 cm-1 (Si–CH3)2 correspond to the molecular vibration. As can be seen from these figures pick of IR spectra of aged insulator samples compared with virgin samples was decreased which means the number of C-H bonds decreases. Pick areas in Si-CH3 in virgin and aged sample are 4 and 1.67 respectively. Also, Peak areas in Si-O-Si in virgin and aged sample are 51.32 and 41.68 respectively. Increasing of ratio (Si-O-Si / Si-CH3) is an index for ageing. In virgin sample, peak area is 12.83 and with increasing ageing it reached to 24.95.

The absorbance at 840- 790 cm-1 is characteristic for Si-alkyl group such as Si-(CH3)2. Absorption occur between 2962- 2920 cm-1 due to an aliphatic C-H stretch in CH3 and between 1270-1255 cm-1 due to asymmetric CH3 deformation of Si-CH3.Also, the absorbance at 1100-1000 cm-1 is due to asymmetric Si-O-Si stretching vibration. The absorption from 3700- 3200 cm-1 is due to Hydrogen bonding from ATH.

The size of specimens was approximately  $(1 \times 1 \times 0.2)$  cm<sup>3</sup> cut from the last shed on the high voltage end of each insulator. They were cleaned using isopropyl alcohol to remove deposition of pollution layer. When the spectra of the aged and virgin samples are compared, there were no significant changes in the bonding functional groups in the samples, indicating that the functional group change of the insulator samples was not identified by the ATR-FTIR technique employed.
